LILLY LAKE NEWS

Lilly Lake Pre-Dredge ~1977

Lilly Lake Post-Dredge ~1981

DREDGING OF LILLY LAKE

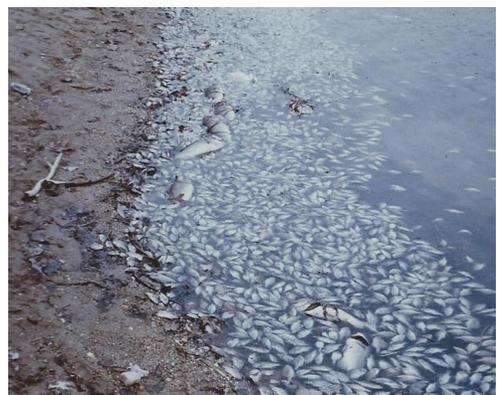
One of the many fish kills in Lilly Lake that occurred prior to dredging.

Historically, problems with the lake were well known (see side bar, and photo below) and several efforts over the years were implemented to improve the lake. In 1974, the Lilly Lake Restoration District was formed by a Town of Wheatland resolution after advisory petitions and public hearings indicated that the majority of the residents were in favor of its formation. The first annual meeting was held in August 1974. In 1976, the name “protection” was added to the name.

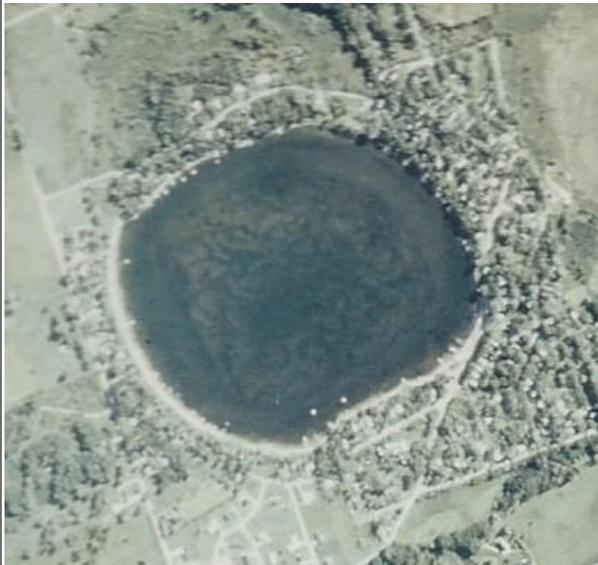
An aerial photo in the 1970s of Lilly Lake prior to dredging. You can see how shallow the lake is and the dense weed growth.

- ◆ Max Depth: 6 ft
- ◆ 30 ft of underlying organic sediments
- ◆ Heavy weed growth
- ◆ Poor water quality
- ◆ Fish kills common
- ◆ Restricted recreational use.

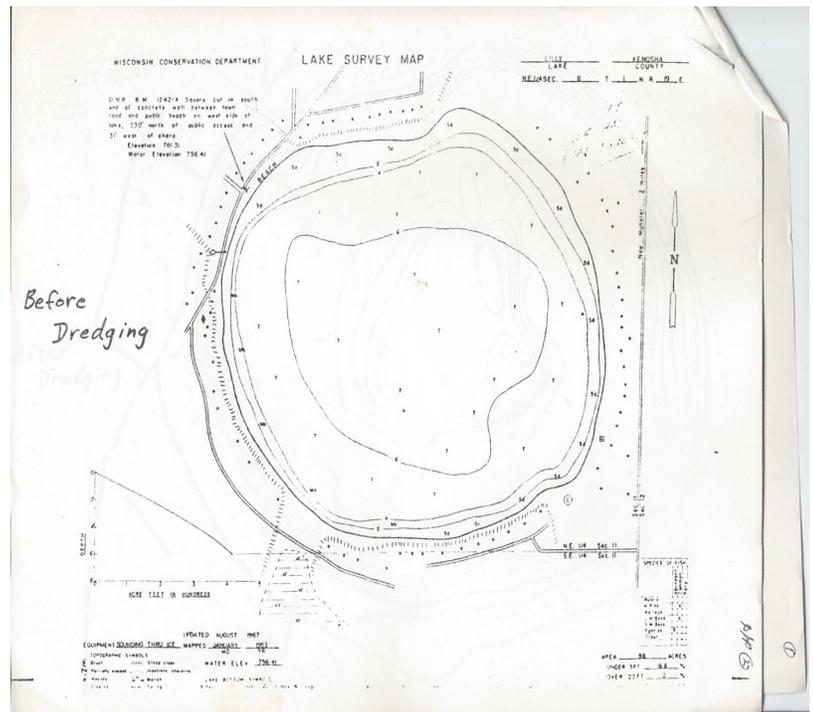
This bathymetric map of Lilly Lake was created prior to the dredging. Although it is hard to see, the maximum depth was only six feet. The dredging plan was to remove approximately 800,000 cubic feet of sediment.

- ◆ Max Depth: 22 ft
- ◆ 800,000 cubic yards of sediment removed
- ◆ Improved water quality
- ◆ Reconnection to groundwater
- ◆ Recreational use greatly enhanced
